莫拉克風災台灣土石流觀測實錄

Debris Flow Monitoring Events in Taiwan during Typhoon MORAKOT

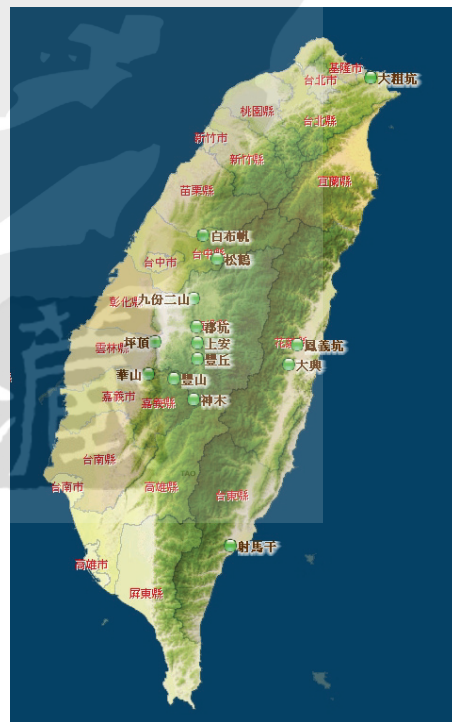
圖 1 固定觀測站分布圖

Fig.1 The distribution of stable monitoring stations

測站，詳細地點如後及圖 1。地點如下：南投縣國姓鄉南港村九份二山、水里鄉郡坑村、水里鄉上安村、信義鄉豐丘村、信義鄉神木村、苗栗縣卓蘭鎮內灣里白布帆、台北縣瑞芳鎮弓橋里大粗坑、花蓮縣鳳林鎮鳳義里鳳義坑、光復鄉大興村、台東市建和里射馬干坑、雲林縣古坑鄉華山村、嘉義縣阿里山鄉豐山村、台中縣和平鄉博愛村松鶴部落及雲林縣林內鄉坪頂村。
